Marine & Pollution Incident Investigation Report

Collision between vessels, Water Park Creek Corio Bay.

Incident date: 21/12/2017

CaseMan no: GSG 42827
(N/A for TOMPA incidents)

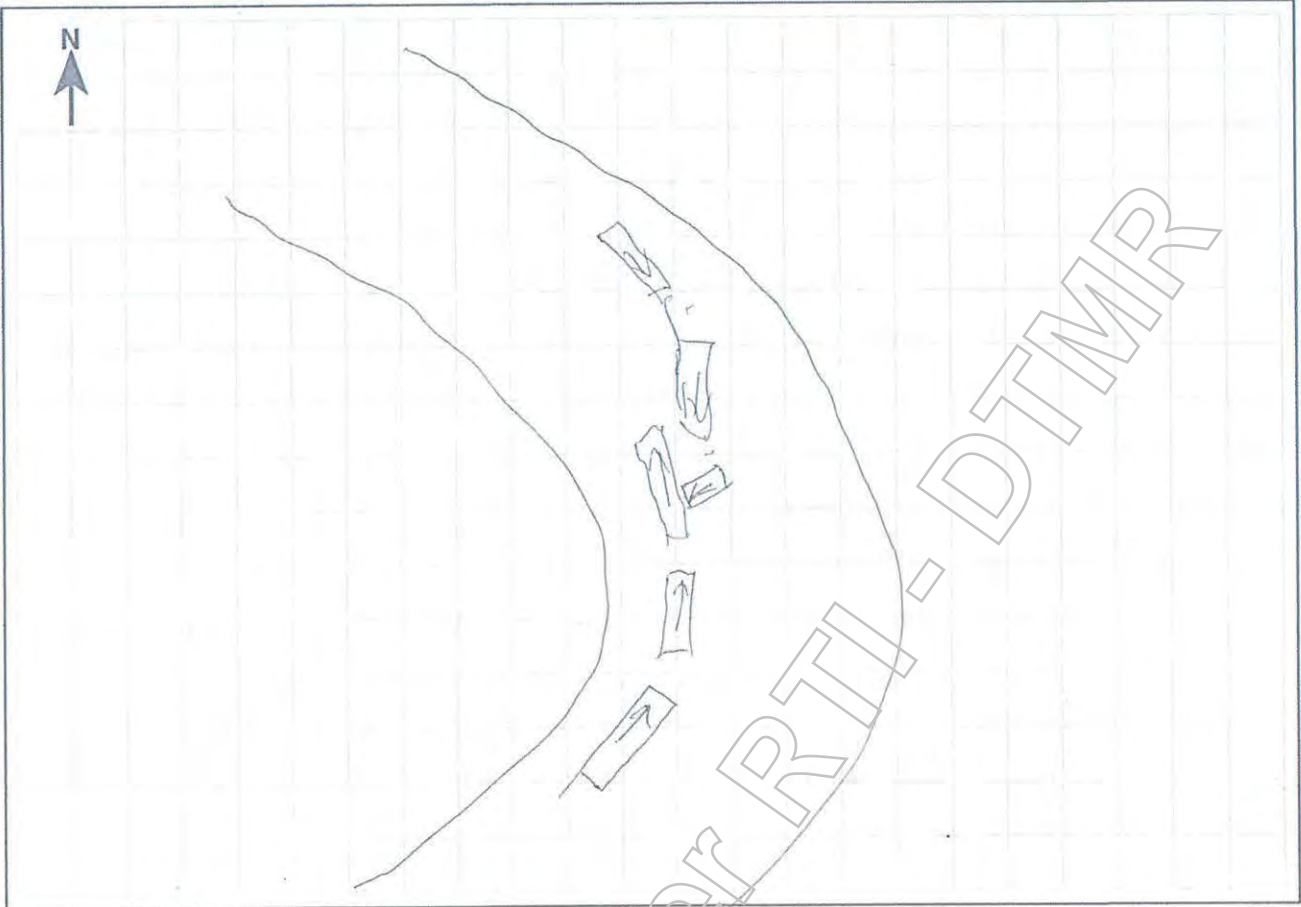
During A LEFT HAND TURN the other vessel
 can devoured to pass on the by doing a
 sharp RIGHT TURN which resulted in
 impact on the front RIGHT OF my
 collision was at SPEED damaged to BOTH vessels
 vessel. NO INJURY reported. although
 1 on board.
