**Technical Note TN143**

**Rehabilitation Technique and Treatment Prioritisation  
Method of Plain Concrete Pavements (PCP)**

**May 2021**

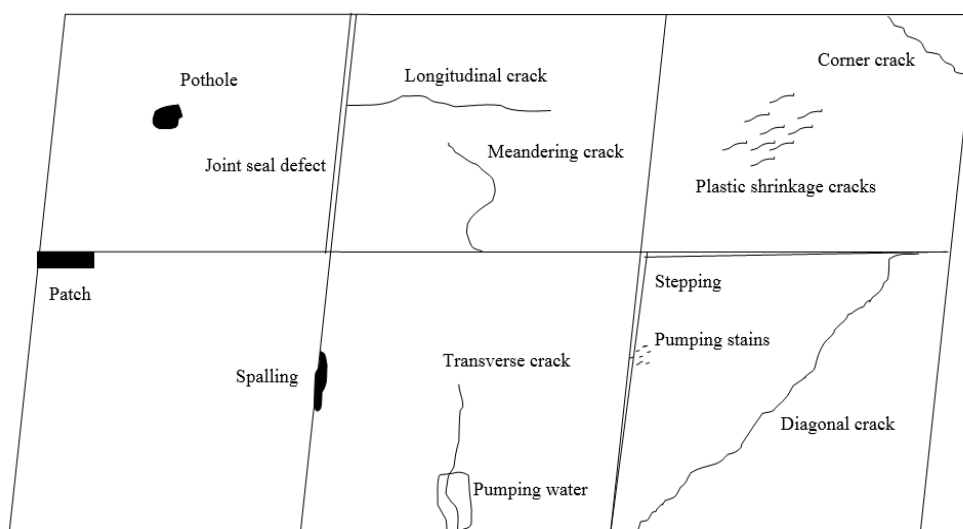
**Figure 5 – Example some of distress modes**

It is important to clearly understand the distinction between the types of pavement failure mechanisms when identifying and assessing distress types, cause of failure and developing rehabilitation strategies. A rehabilitation project may not adequately correct the pavement deficiency with an incorrect classification of the failure mechanism.

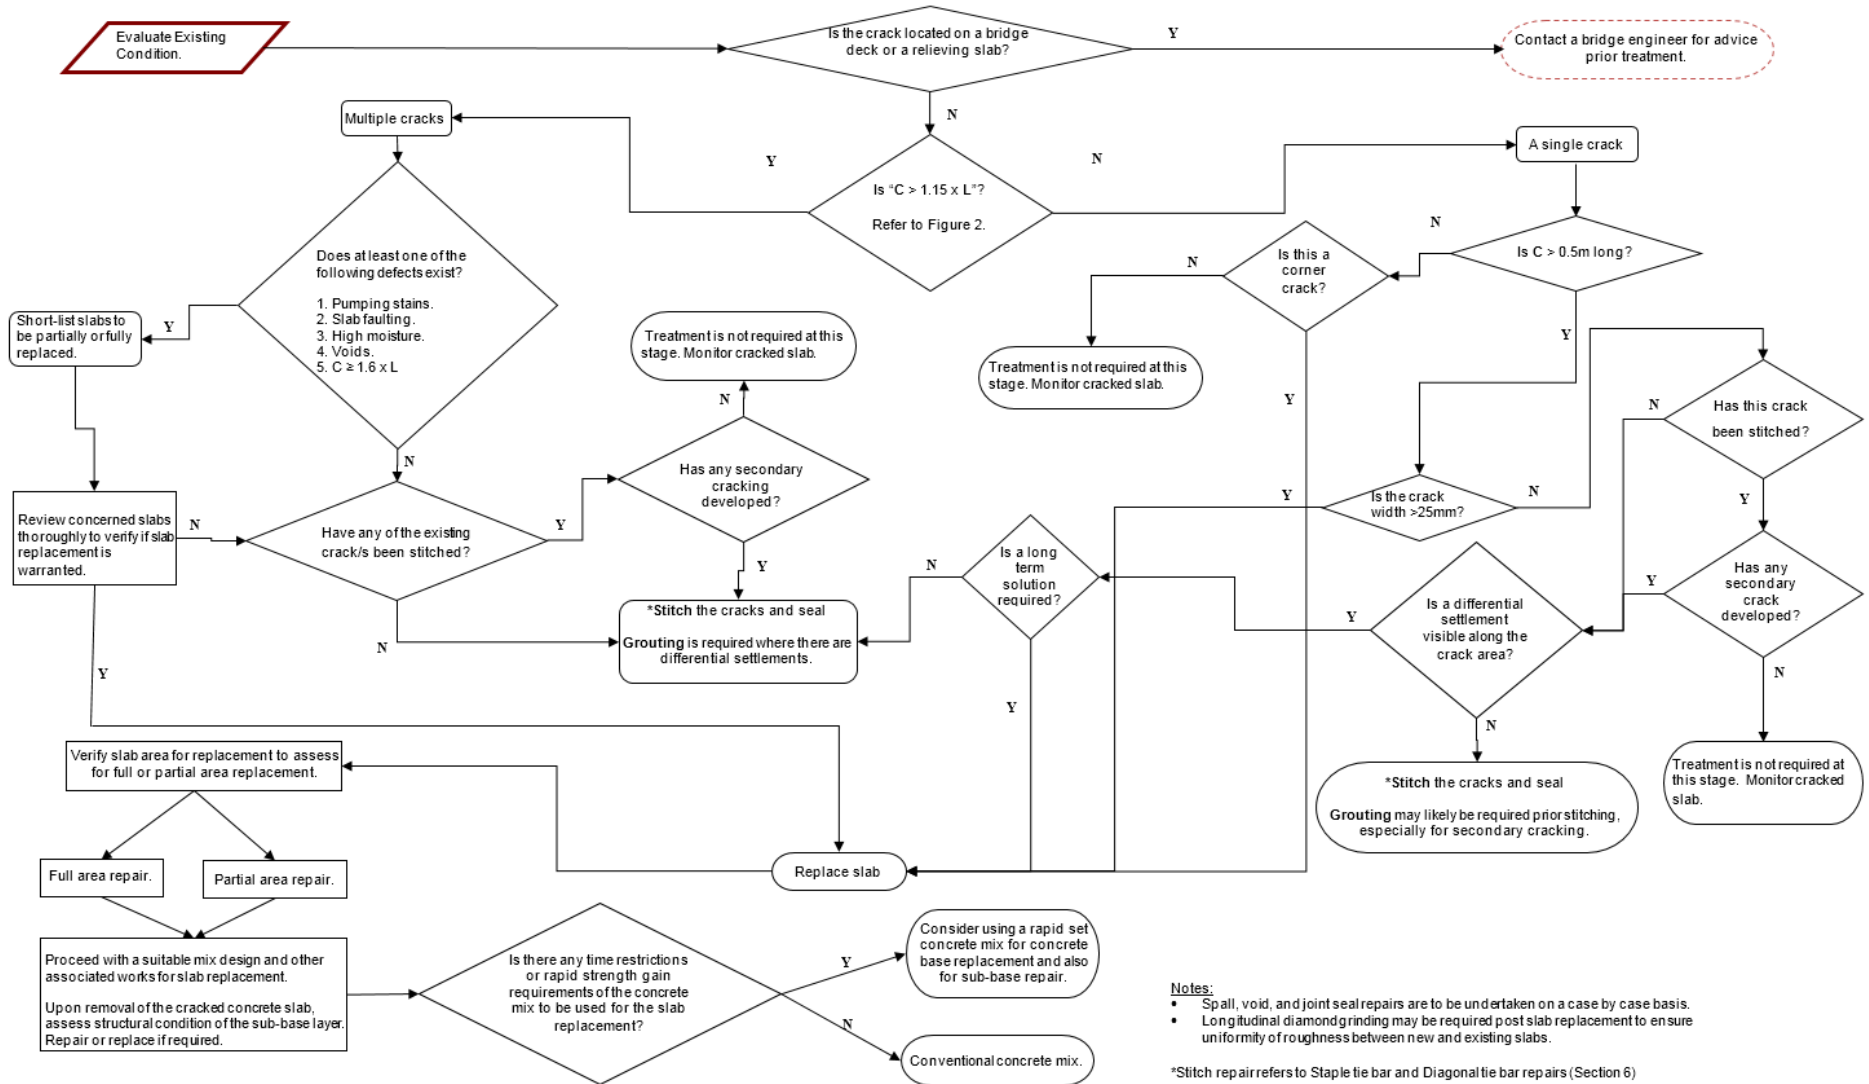
Figure 6(a) – Flowchart 1 - Plain concrete pavement rehabilitation treatment prioritisation and identification

Figure 6(a) Flowchart 1 following has been developed by the department's Pavement Rehabilitation Unit to handle and analyse the data collected during the existing condition evaluation. The flowchart illustrated assists with treatment prioritisation and identifies the likely suitable treatment method to rectify failed concrete pavements.

Roads and Maritime Services (RMS) NSW has developed standard drawings and specifications for the PCP treatments. These technical documents have been developed to suit NSW conditions. Upon discussion / approval from the Administrator, part of these standard drawings and specifications may be adopted for Queensland-based projects. Alternatively, the Principal Contractor shall submit work method statements to the Administrator for approval. The following section defines the treatments as identified in Flowchart 1 previously.

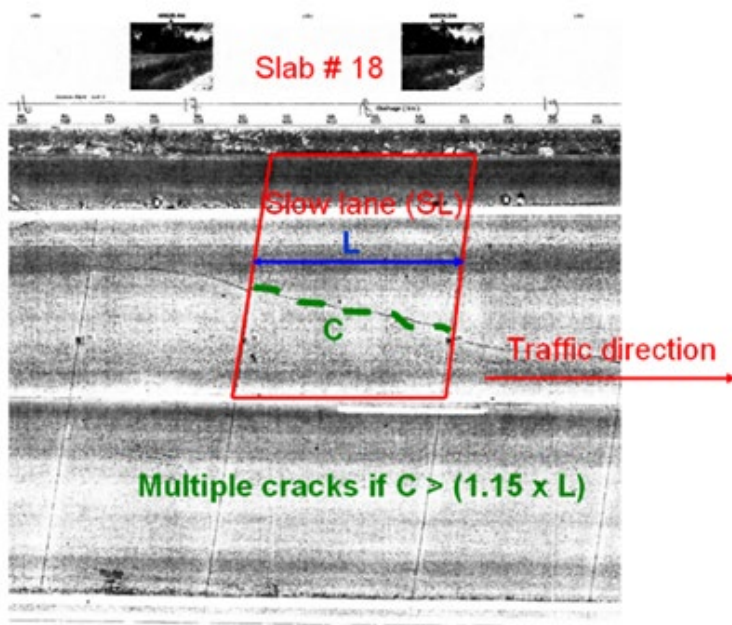
**Figure 6(b) – Cracking length (C) and slab length (L)**

Within Flowchart 1, 'C' is defined as the combined cracking length in a slab and 'L' is the slab length as shown in Figure 6(b), following.

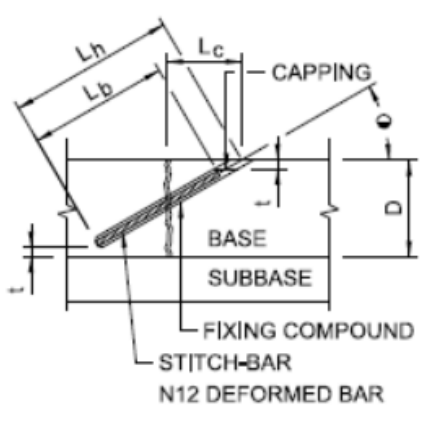
**Figure 7(a) – Diagonal tie bar repair**

Base thickness D (mm)	Offset: drill hole to crack L <sub>c</sub> (mm)	Length of drill hole L <sub>h</sub> (mm)	Length of stitch-bar L <sub>b</sub> (mm)	Length of protection L <sub>p</sub> (mm)
190	165	330	280	40 ± 5
200	175	350	300	40 ± 5
210	180	370	320	45 ± 5
220	190	390	340	45 ± 5
230	200	410	360	45 ± 5
240	210	430	380	50 ± 5
250	215	450	400	50 ± 5

1. To suit drill angle of 30° and cover (ct) of 25 mm, refer to above diagram.
2. See Figure 7(b) following for protection details (L<sub>p</sub>). Protection must be provided if the crack is wider than 0.5 mm. The suitable protection is by bituminous paint with a thickness of 0.2 mm to 0.5 mm.

- **Diagonal tie bar repair (cross stitch)** – insert reinforced steel rods diagonally and epoxy resin to hold the crack together. It is used only for cracks or joints that are not intended to open / close and is generally unsuited to concrete slab thicknesses less than 190 mm and when the cracking gap is greater than 25 mm. Refer to Figures 7(a), 7(b), 7(c), 7(d), 7(e), 7(f), 7(g) and 7(h) following for technical guidelines.

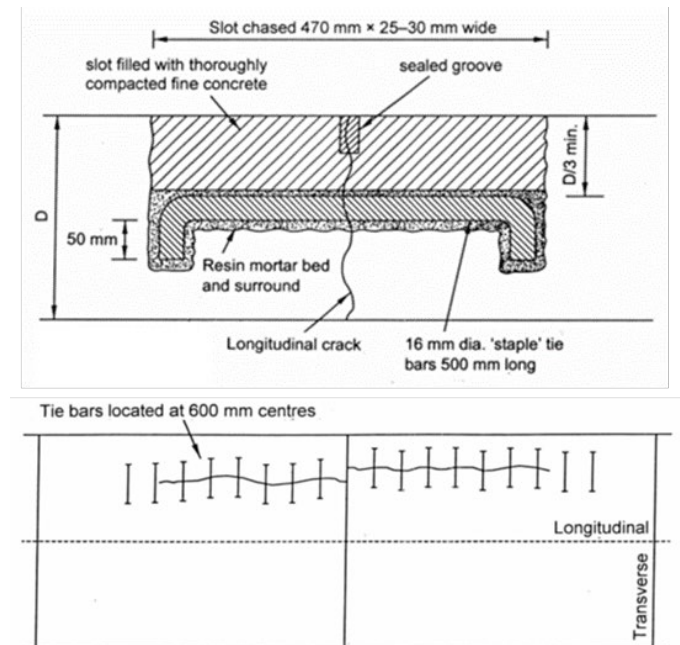
**Figure 7(d) – Staple tie bar repair**

- Staple tie bar repair** - tie slabs together at cracks or joints to evenly distribute the load across both the crack and un-dowelled concerned joint. The implementation of the staple tie bar repair in Queensland has been limited, when compared to the diagonal tie bar repair (cross stitching). This treatment has been undertaken on several existing longitudinal cracks on the concrete slabs on the Bruce Highway, Sippy Downs area.

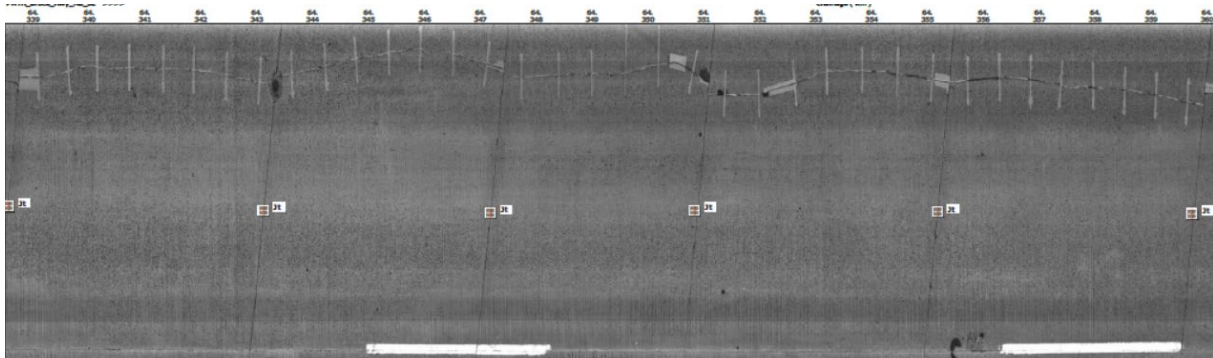
**Figure 7(e) – Staple tie bar repair at concrete pavement of Bruce Highway on Sippy Downs – Northbound Slow Lane from approximately Chainage 64,339 km–64,360 km**

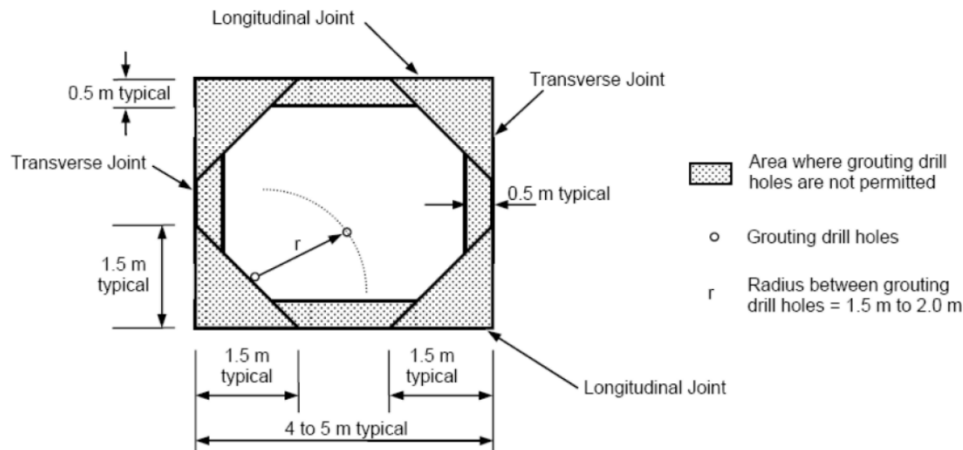
**Figure 7(f) – Typical grout hole arrangements for PCPs**

1. Carry out a one-day production field trial to establish a site-specific working procedure.
2. Submit proposed nominated grouting mix for approval. The minimum grout compressive strength shall be 8 MPa at 24 hours.
3. Set up locations of grouting holes to ensure vertical and horizontal filling of voids is achieved. The radius between grouting drill holes is usually between 1.5 m to 2 m. The grouting hole must not exceed 50 mm diameter. Refer to Figure 7(f) for details.
4. Determine the grouting depths. Insert a sleeve into the grout holes for a deep grouting below the sub-base concrete layer. The sleeve shall pass completely through the base concrete and sub-base concrete. Remove the sleeve after the grouting is completed.
5. Monitor the slab level regularly during void grouting or slab jacking using survey level equipment.

- **Pressure Grout injection for slab stabilisation:** it restores support to concrete slabs by filling voids that develop underneath the concrete slab at joints, cracks or the pavement edge. Slabs that have 'dropped' can be lifted by the grout pressure to restore the surface profile to match surrounding slabs. In general, voids can be formed at different pavement strata which determine the target grouting depth as follows:
  - shallow grouting: target voids between concrete base layer and a sub-base layer, and/or
  - deep grouting: target voids below the sub-base layer; that is, granular layer, fill, sub-grade replacement layer or sub-grade layer.

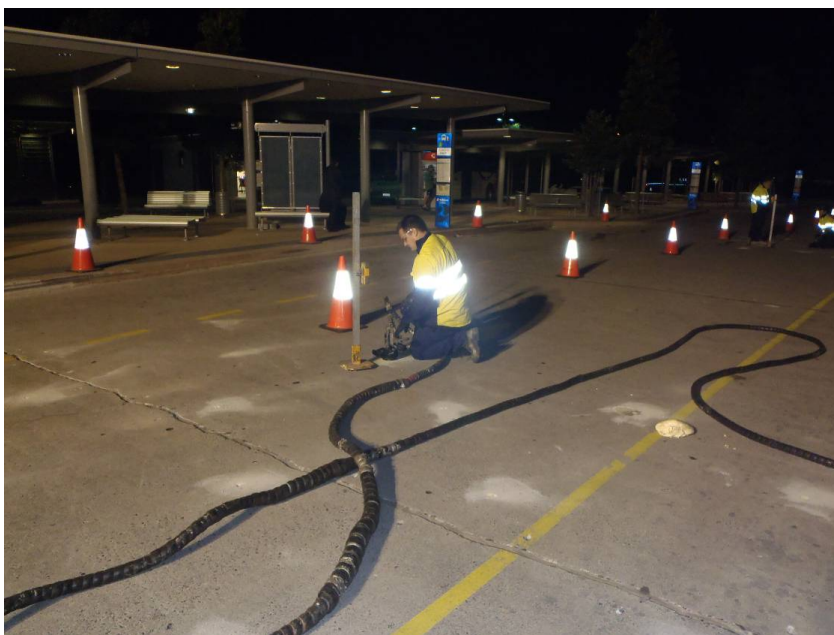
For the expanding polyurethane foam grouting, the premix grouting liquid is stored in a vacuumed tank and is delivered on site in a tanker truck. The truck is equipped with a pressure pump to inject the expanding polyurethane directly to the grouting holes. The required site preparation is minimal compared to the cementitious grouting, but usually costs more than the cementitious grouting. The grouting holes are generally 10 mm to 15 mm in diameter and can be plugged using the same grouting material (the expanding polyurethane foam grouting). The grouting shall have a sufficient curing time to achieve the required strength prior to opening for traffic.

**Figure 7(g) – Pressure injecting grout using expanding polyurethane foam - Logan Hyperdome bus station**

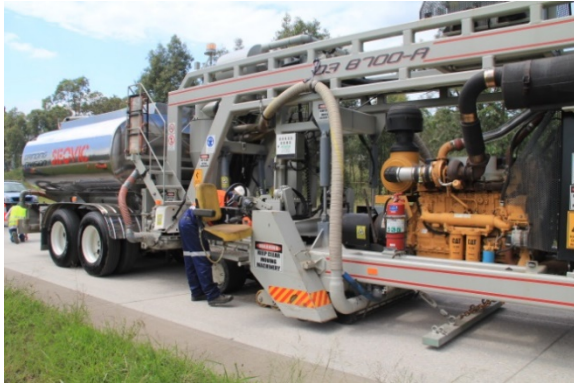
**Figure 7(h) – Diamond grinding in progress**

- **Longitudinal Diamond Grinding:** it restores or improves skid resistance, removes faults at joints or cracks by levelling the pavement surface and reduces traffic noise.
